## RR607/RR6088 Trailer Trouble Shooting:

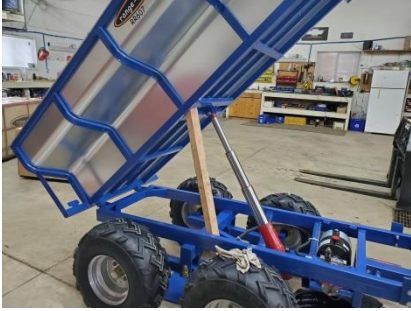
- 1) Use a 2x4 or other strong material to prop the tub/deck solidly, this support will be holding the full weight of the tub/deck in the air so make sure it is strong enough.

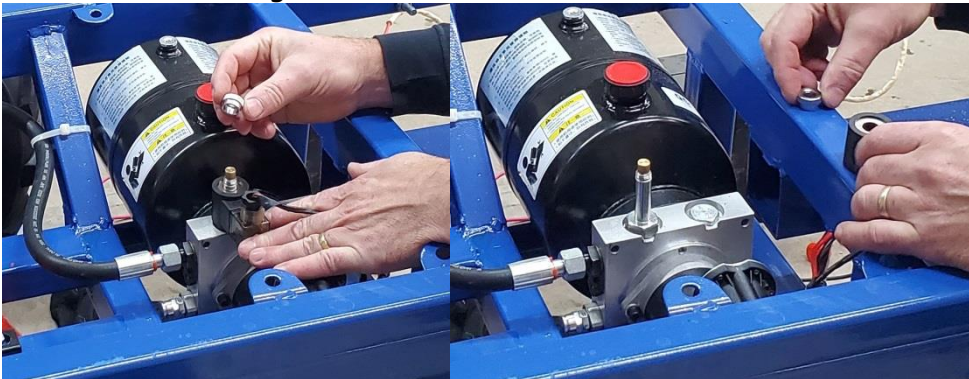
- 2) Use the remote control to lower the cylinder, putting all of the weight on your support and taking the pressure off the hydraulics.
- 3) Undo the nut holding the solenoid and the remove the solenoid, this nut is only hand tight.

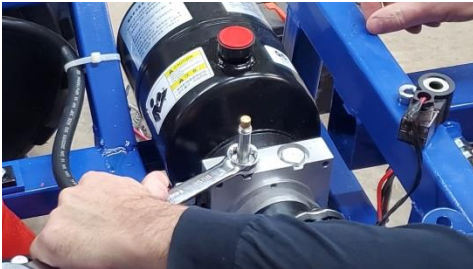
- 4) Use a 15/16 wrench to undo the solenoid housing slowly.

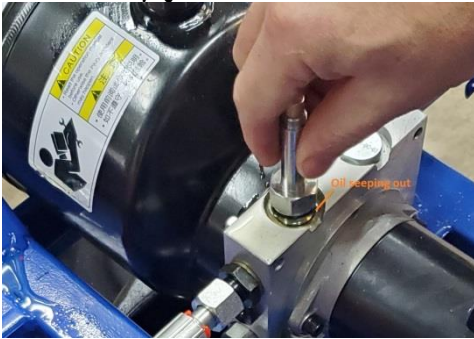
5) When oil starts to seep out of the threads, stop turning until there is no pressure left in the oil coming out, usually just a few seconds.

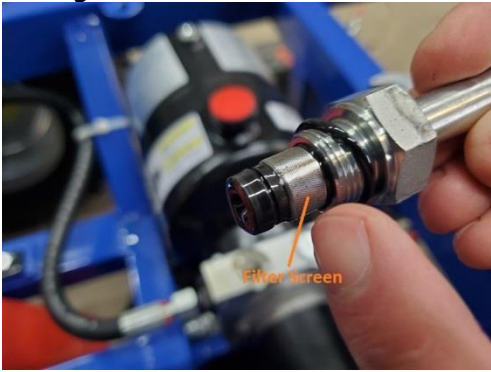
6) When you pull the housing out you will see the stainless steel screen that needs cleaned, use brake cleaner or degreaser and a brush to clean the screen out. Screen can be removed if necessary for cleaning.

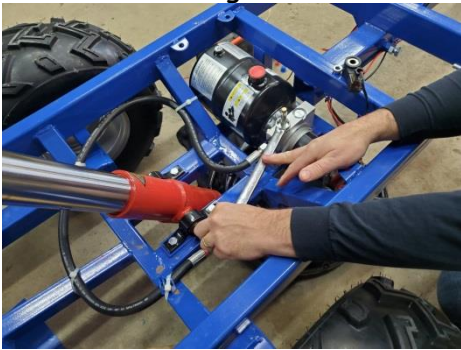
7) Re-install housing with clean filter using 15/16 wrench.

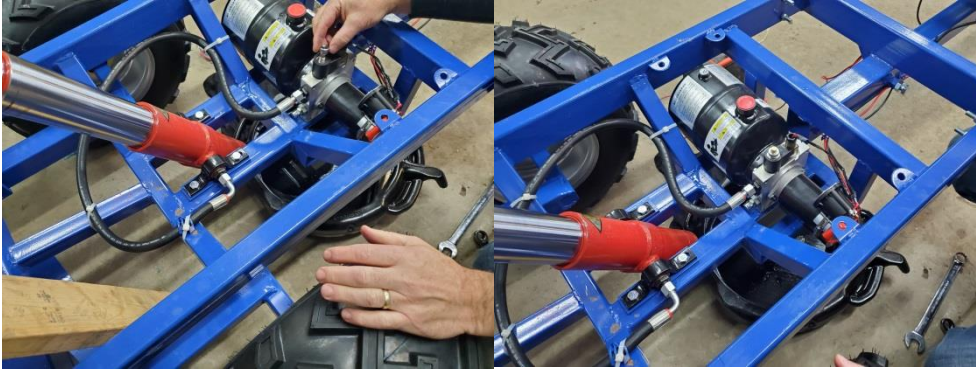
8) Re-install solenoid and tighten nut by hand only.
