RR607/RR6088 Trailer Trouble Shooting:

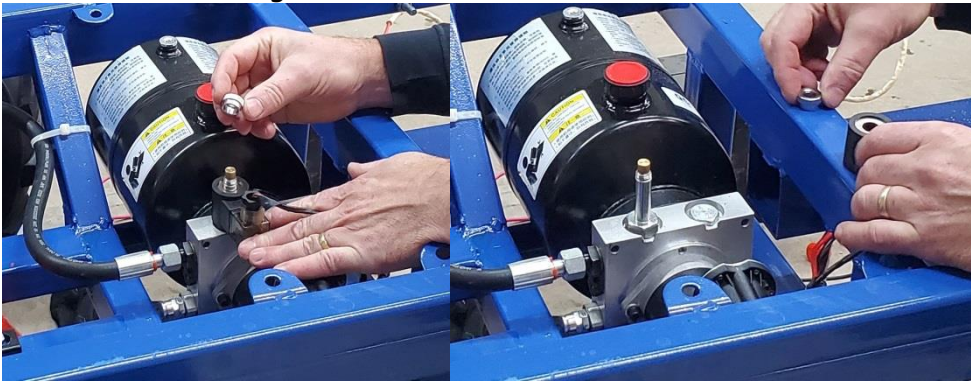
- 2) Use the remote control to lower the cylinder, putting all of the weight on your support and taking the pressure off the hydraulics.
- 3) Undo the nut holding the solenoid and the remove the solenoid, this nut is only hand tight.
